Impact of Hurricane Ivan in Grand Cayman

A technical review of the hazards
and their effects

Simon Young & Tony Gibbs

Submitted: 18 February 2005

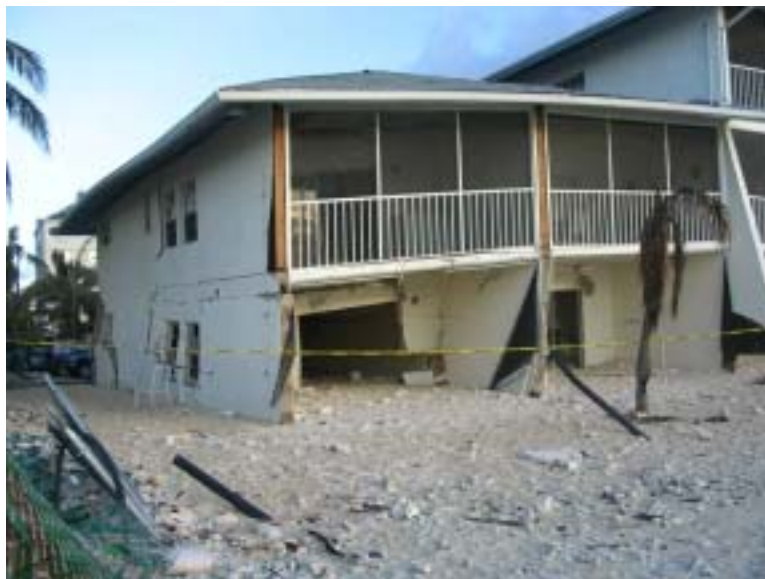
Figure 2.11 Damage at this location on Seven Mile Beach was due to erosion by fast-moving storm surge flood water confined to a narrow passageway between buildings.

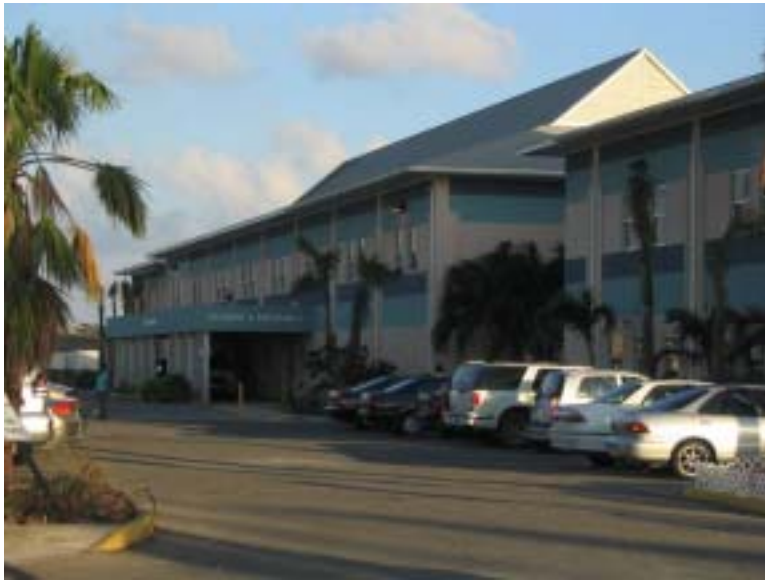
Figure 3.1 Minor loss of roof covering was the only damage inflicted by the wind on the new Cayman General Hospital; flooding damage was more extensive.

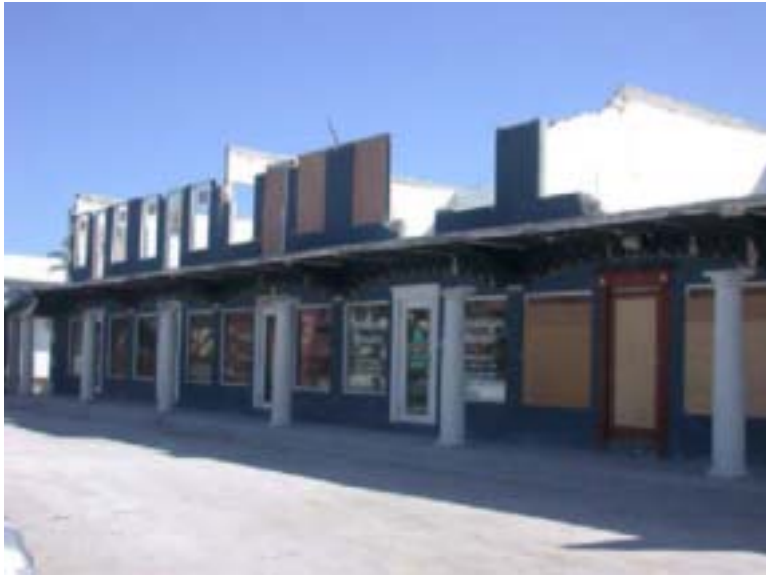
By and large Ivan was a success story for the CIG Building Control Unit headed by Mr McCleary Frederick. There was only moderate structural damage to buildings designed and constructed after the introduction of the Cayman Building Code. Older buildings were noticeably more vulnerable from a structural point of view and, indeed, suffered more damage (Figure 3.3).

Figure 3.3 Severe damage to the upper level of a pre-code un-reinforced masonry building by wind during Ivan.

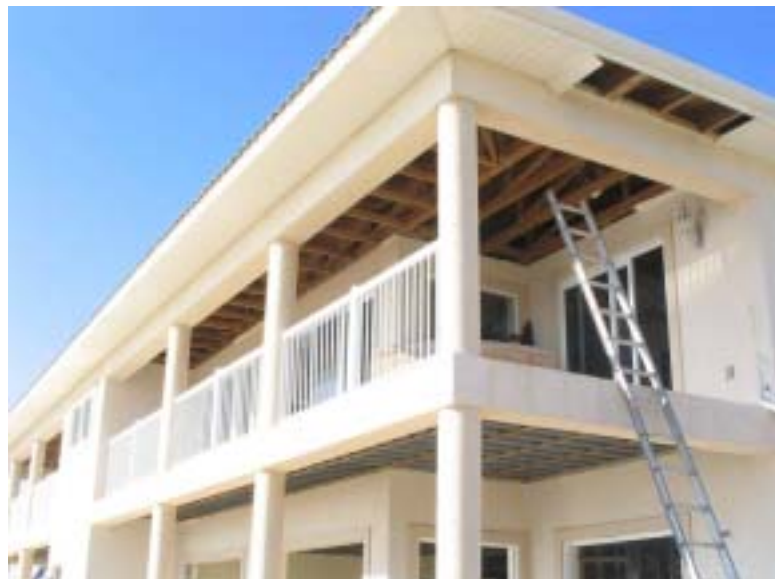
Figure 3.4 Boxed-eave coverings suffered extensive damage and allowed major water ingress to many residential and hotel properties.

It is clear that the Building Control Unit is absorbing the lessons from Hurricane Ivan. The care and attention previously given to structural aspects of design and construction will now be replicated for non-structural components. Siting regulations will be reviewed. Materials and applications which fared particularly poorly may be embargoed in the rebuilding process; however, it is not recommended that a prescriptive standards approach be taken in this case.

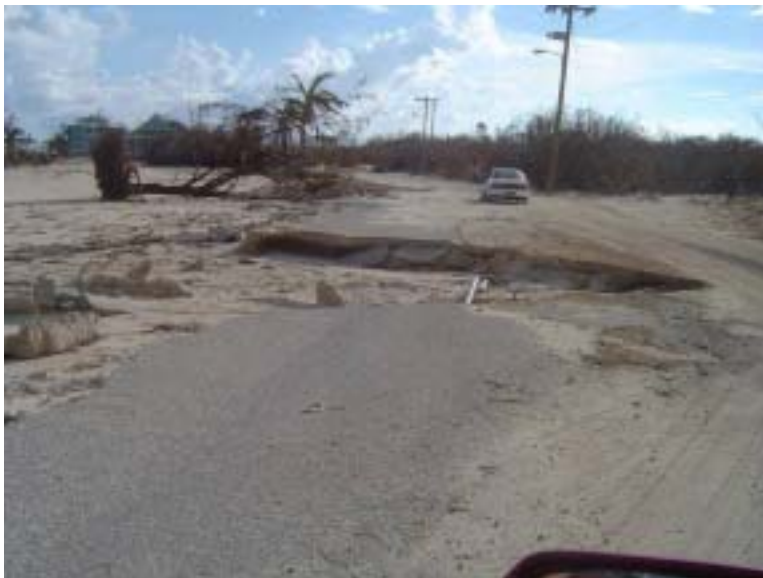
Figure 3.5 Severe road damage along the south coast west of East End.

Repairs are in progress and in some areas the opportunity is being taken to realign the road further inland.

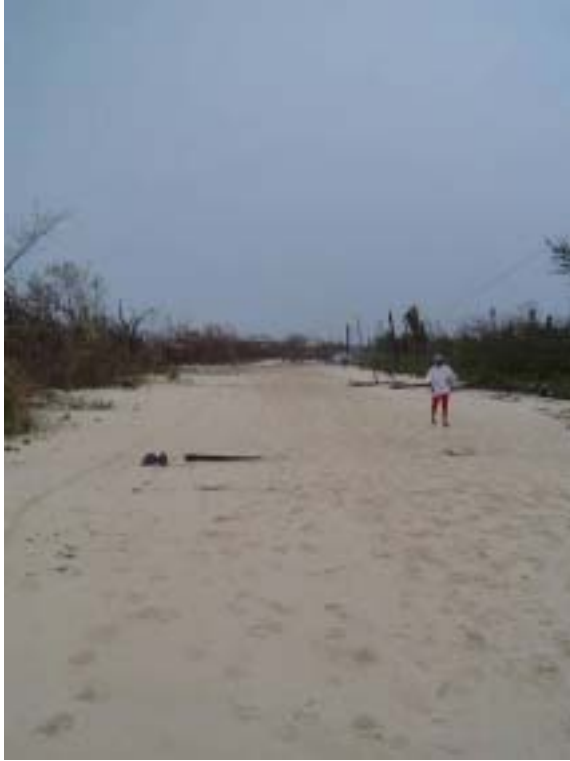
Figure 3.6 West Bay Road adjacent to Seven Mile Beach, where storm surge flooding carried and deposited sand across the roadway.

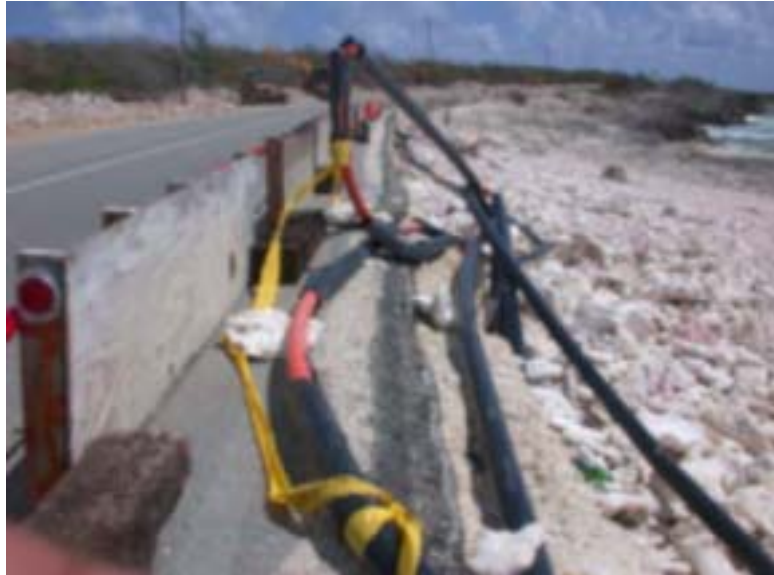
Figure 3.8 Fibre-optic cables exposed by erosion of the south coast road.

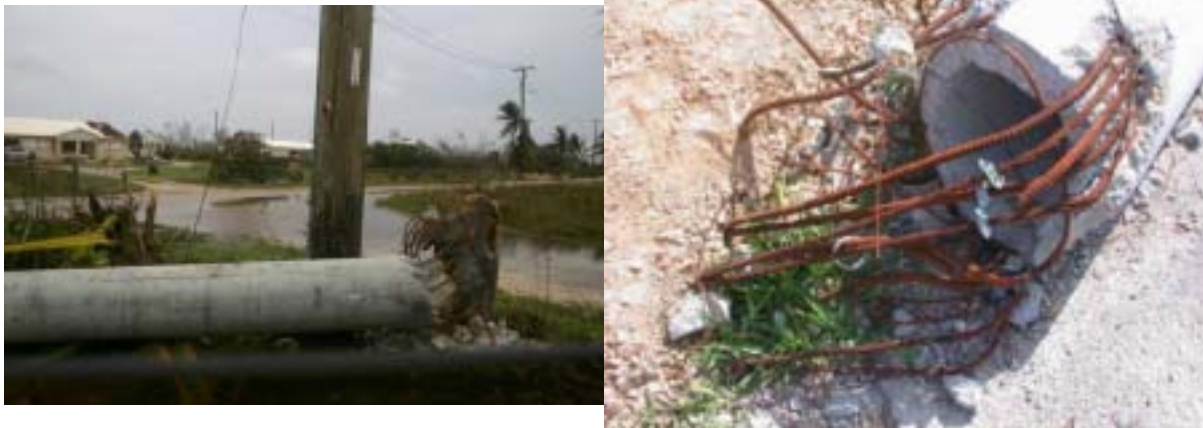
As indicated above, distribution poles were lost in a significant number of cases. A few pre-stressed concrete transmission poles broke along the long north-south leg of the distribution system at West Bay (Figure 3.10) and at least one broke in a relatively low-wind setting (Figure 3-11; likely due either to a pole flaw at a bolting point or to poor installation of fitments at the bolting point). This does not indicate a negative view of their continued deployment for this purpose.

Figure 3.10 Failure of concrete distribution poles in the West Bay area.

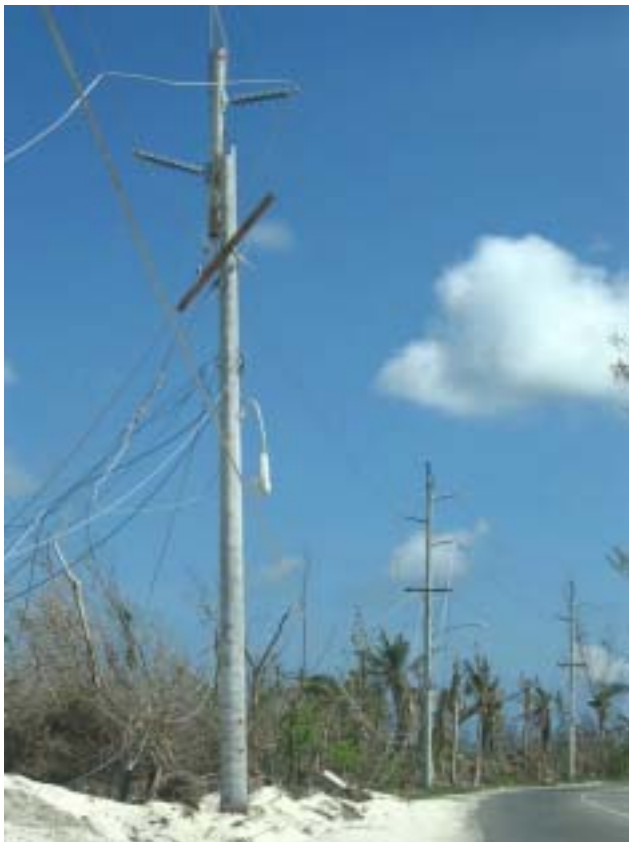
Figure 3.11 Failure of concrete pole at a bolting point. Along south coast road near Bodden Town.

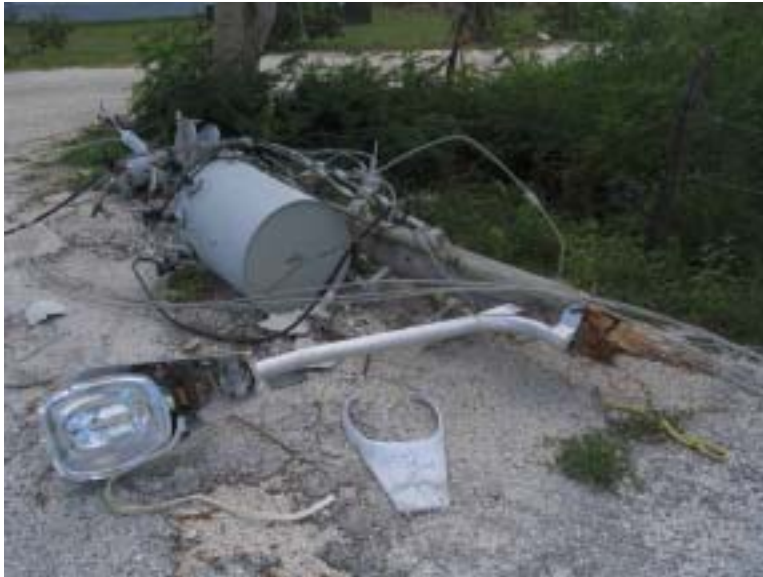
Large numbers of wooden poles were damaged along West Bay Road (a long stretch of north-south running cabling) due to a combination of across-wind spans, multiple cables and frequent up-pole transformers. In other areas, up-pole transformers were the dominant reason for pole failure (Figure 3.12).

Figure 3.12 Uppermost part of wooden distribution pole broken by wind due to increased total wind pressure (due to higher surface area resisting the wind) and increased gravitational load (weight of the transformer).

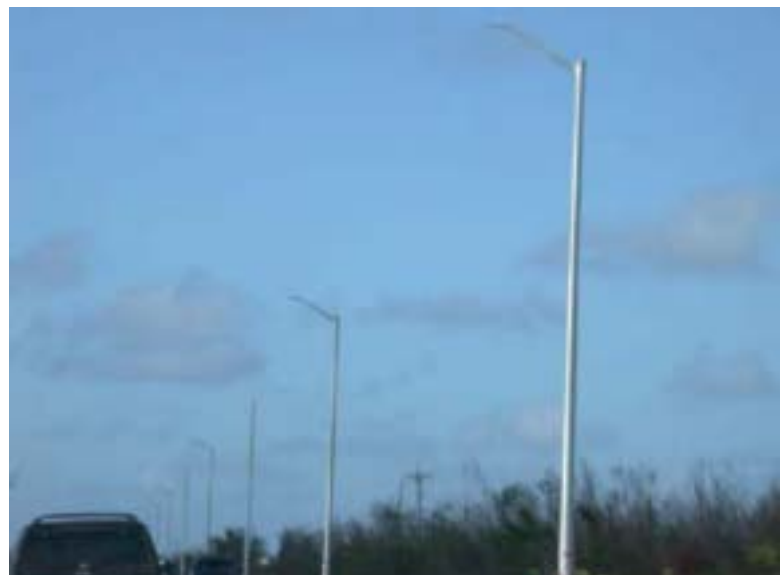
Figure 3.13 Street lights lost from stand-alone poles.

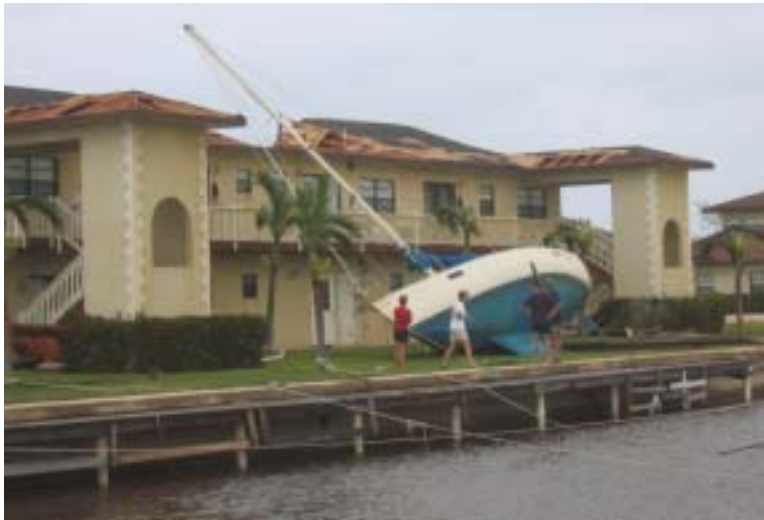
The heavy storm surge flooding coming from North Sound badly affected the newly developing marina areas on the western side of the sound (Governor's Harbour, Snug Harbour and The Shores); many pleasure boats came aground in elevated positions (Figure 3.14).

Figure 3.14 Boat aground at Foster Bay Villas.

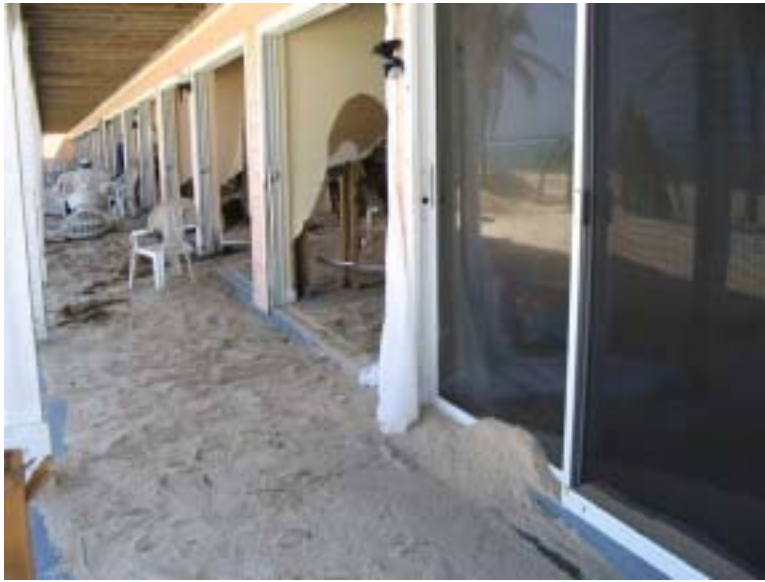
Figure 3.15 Storm surge flooding caused extensive damage to ground floor rooms in most beachside properties around Grand Cayman. This is the Morritt's Tortuga Club at the north end of the east coast.

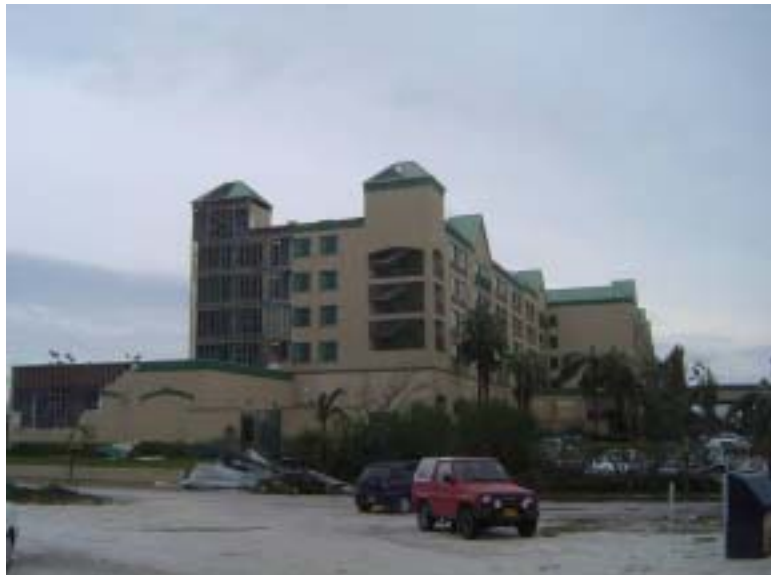
Figure 3.16 Extensive damage to cladding at the eastern end of north-facing walls at the Holiday Inn on West Bay Road.

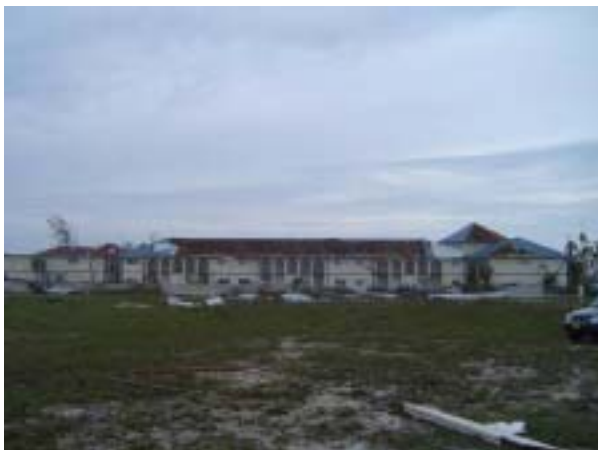
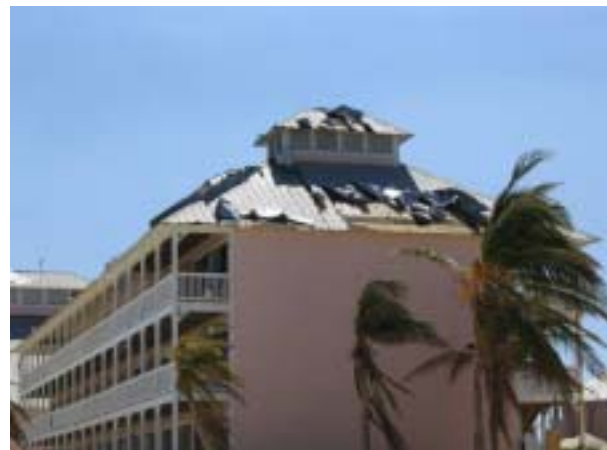
Figure 3.17 (below) Major roof covering damage to Indies Suites on West Bay Road (left) and minor damage to the much newer Morritt's Tortuga Club (right).

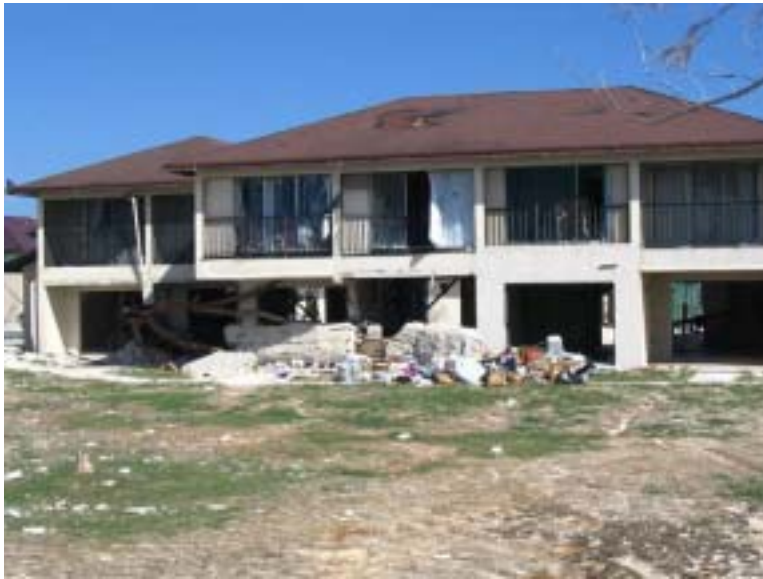
Figure 3.18 Ocean Club along South Sound; next door, the wooden structures of Mariner's Cove were completely destroyed. Note parts of the sea wall used as a battering ram causing severe structural damage.

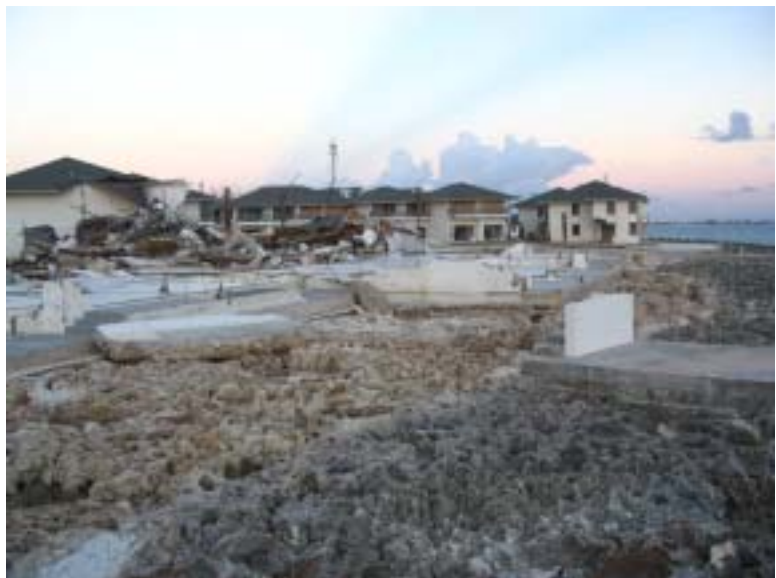
Figure 3.19 Dolphin Point, West Bay. Onshore winds late in the storm drove heavy waves into this and adjacent properties, causing massive damage, even to well-built reinforced masonry structures.

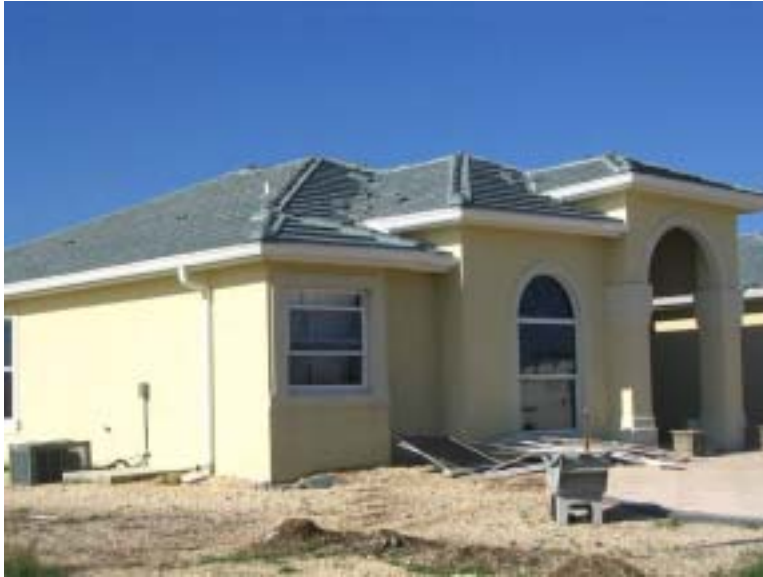
Figure 3.22 Clay tiles removed from the east-facing roof and from ridges on this house in Governor's Harbour.

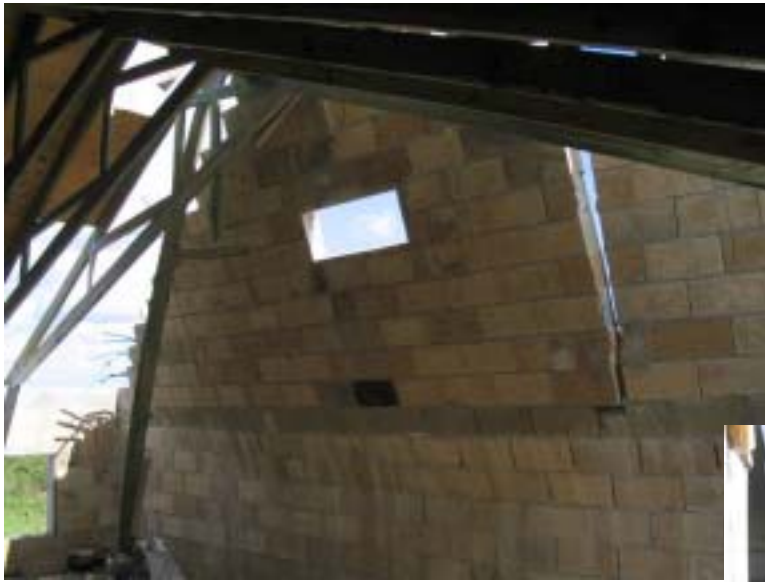
Figure 3.24 Compromised gable end in a house under construction.

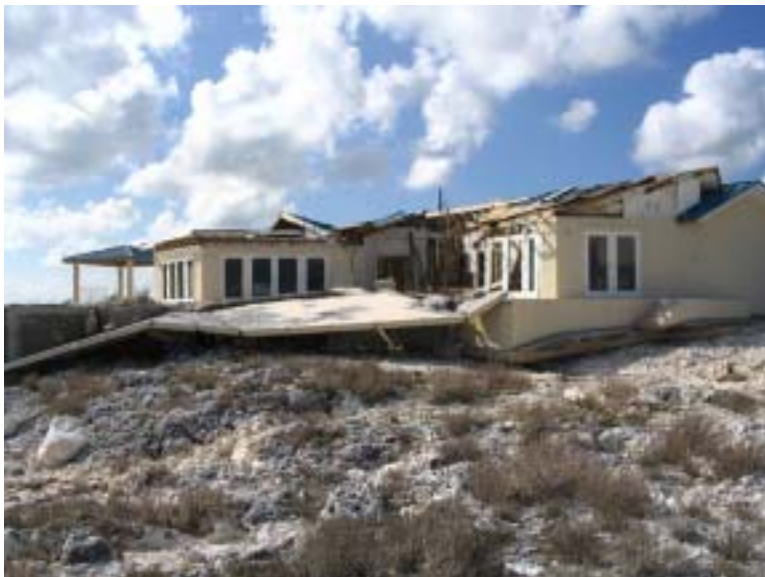
Figure 3.26 Extreme wave damage at High Rock; this property is about 25 ft above sea level and several hundred feet from the shoreline.

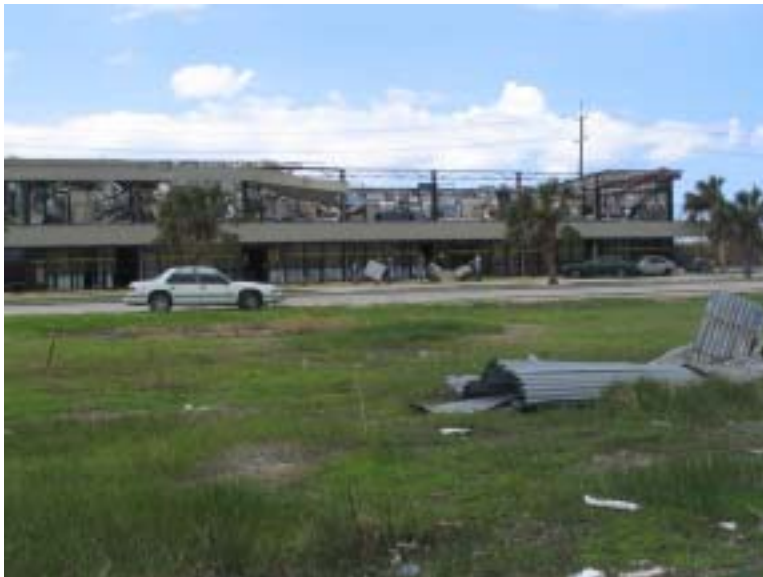
Figure 3.29 Loss of long-span galvanised roofing and subsequent destruction of the entire property was frequent around George Town.

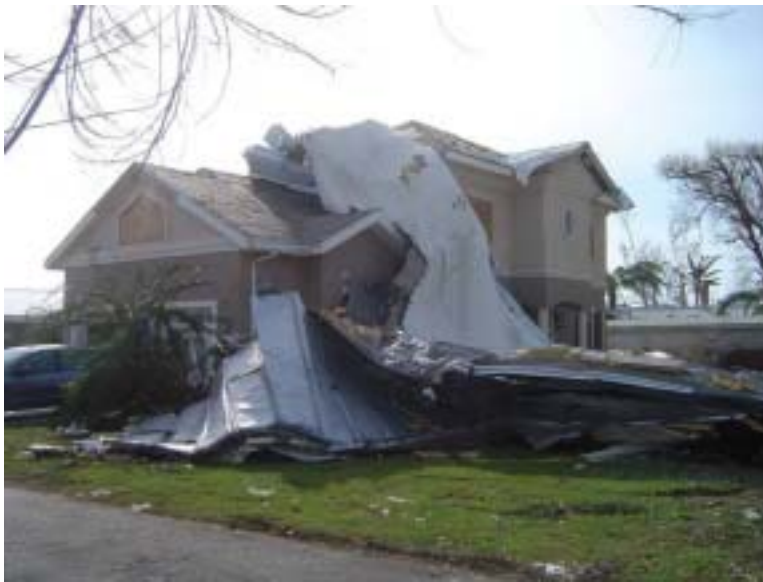
Figure 3.31 The roof from a neighbouring building caused significant damage to this otherwise well-protected residential home.

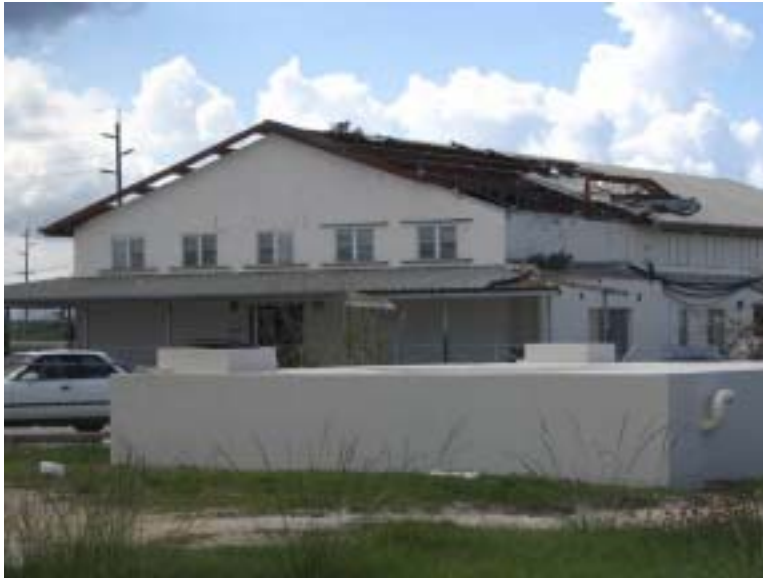
Figure 3.32 Extensive roof damage at Bodden Town Civic Centre, which at the time was being used as a shelter.

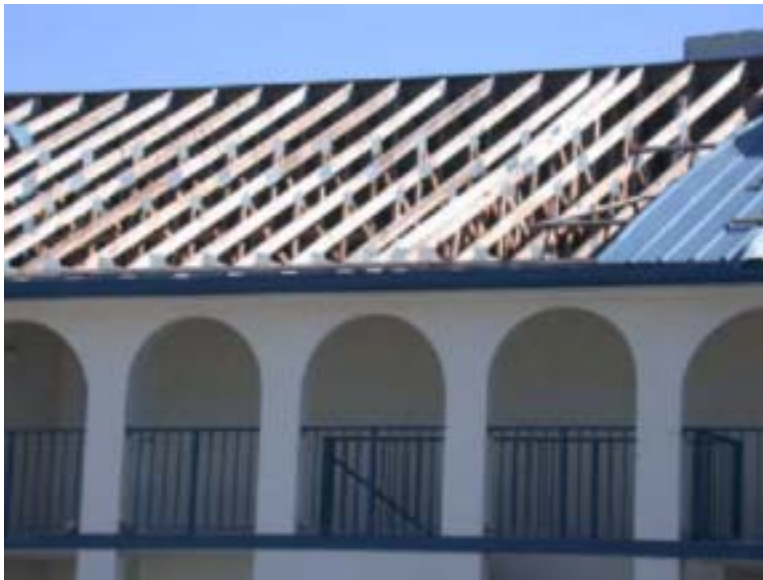
Figure 3.33 Galvanised connector plates on roof trusses kept the roof structure intact, although the roof covering was lost.
