Impact of Hurricane Ivan in Grand Cayman

A technical review of the hazards
and their effects

Simon Young & Tony Gibbs

Submitted: 18 February 2005

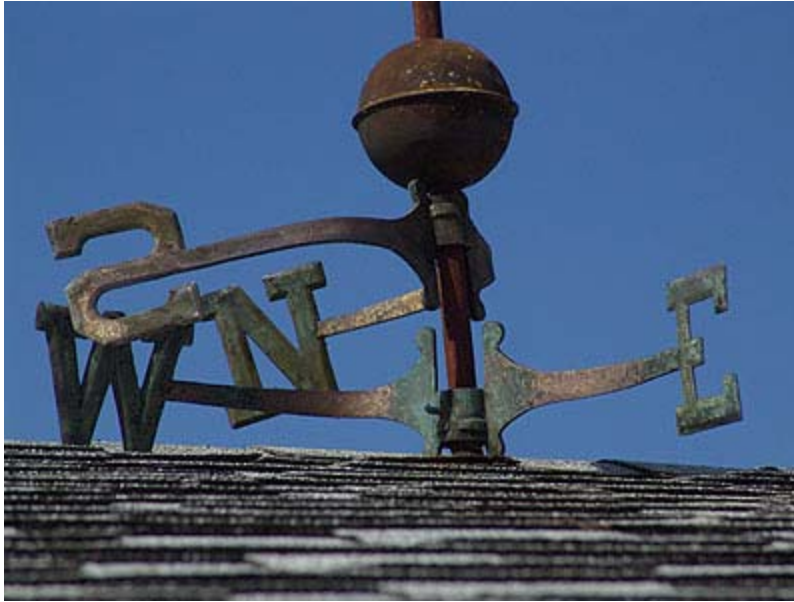
A tabulation of key data is provided as Table 2.1. The peak wind speed for West Bay from the model is about 10% lower than that recorded by the anemometer; this discrepancy is well within the likely errors in the anemometer data. The distribution of peak winds across the island is consistent with damage levels on a gross scale (*i.e.* much more damage in the west than the east); however, local conditions related both to perturbations in the windfield and to design and quality of buildings dominate variations in damage on a local scale. All indicators show that peak winds were out of the east across the entire island (Figure 2.7), and the model is entirely consistent with this observation.

Figure 2.7 A clear indicator of Ivan's peak wind direction.

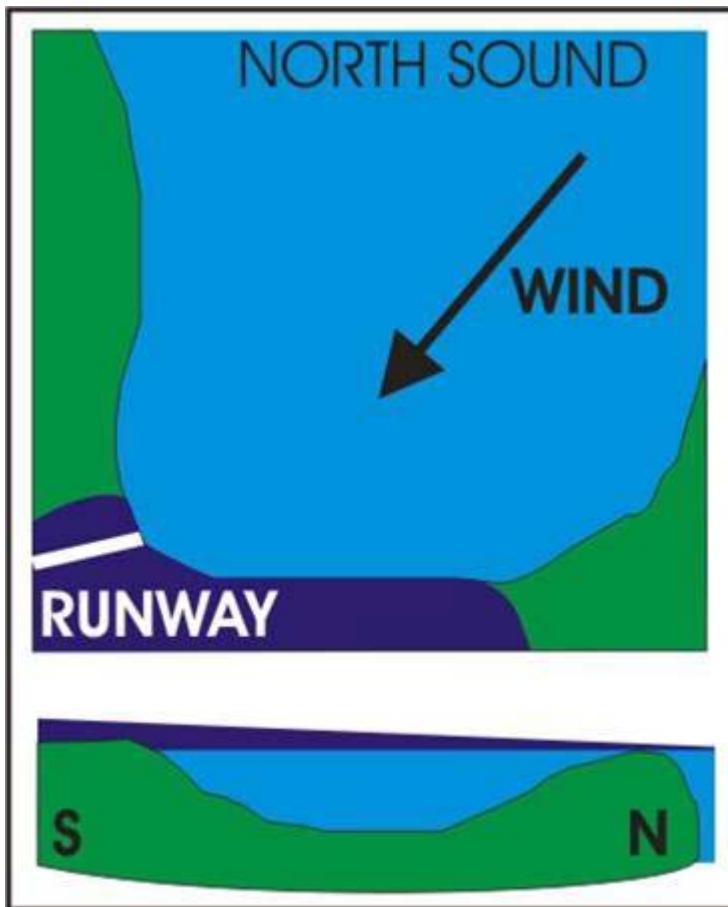
The geometry of North Sound (Figure 2.10) caused the unanticipated, though not unpredicted nor unprecedented, storm surge flooding through the Red Bay-Prospect neck and across the western peninsula. Similar breaching of the Red Bay-Prospect area has occurred on a number of occasions in recorded history on Grand Cayman (*e.g.* hurricanes in 1731, 1751, 1846, 1915, 1932, 1933, 1944 and 1988, see section 4.4 in Young, 2004), although the extent of flooding was perhaps greater than on any previously recorded occasion.

A key to understanding the unique bathymetry of North Sound and its influence on storm surge is the observation that storm surge flooding in Cayman Kai, seemingly highly exposed at the northern entrance to North Sound, was just 1-2 ft. This proves that there was a substantial slope in the water surface of North Sound, up towards the southwest, achieving a height difference of at least 6 ft from northeast to southwest around 6 am on 12 September.

Figure 2.10 Cartoon of the southern part of North Sound in plan (top) and cross-section views. Light blue is the normal water level, dark blue represents the wind-blown surge element.

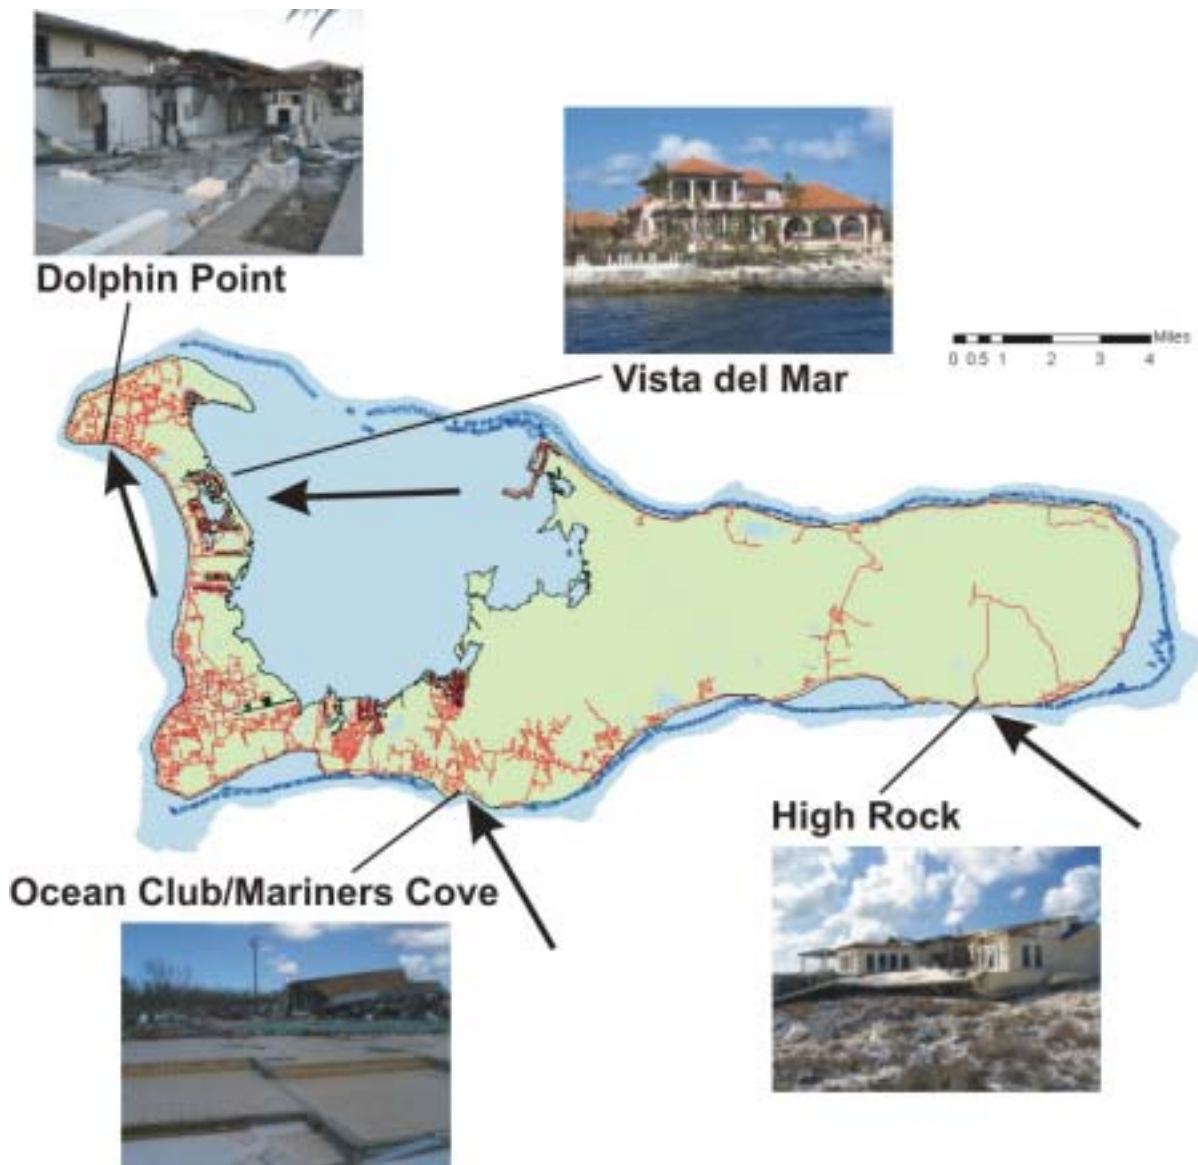
Wave damage along the coast of Grand Cayman was highly variable in its nature. The variability in damage levels was entirely controlled by the presence or absence of shallow offshore coral reefs and the presence or absence of onshore winds during the storm. Waves break in shallowing water; even with the storm surge, the reefs which surround most of the south, east and north coast of Grand Cayman were sufficiently shallow to cause waves to break, thus dissipating almost all of their energy. The relatively unprotected west coast (where reefs are deeper) was fortunately not subject to onshore winds. Thus severe wave damage occurred only in a few places where onshore winds and no reef protection came together. These areas are shown in Figure 2.12.

Figure 2.12 Key elements of wave damage around the coast of Grand Cayman. Large arrows indicate wind direction when damage was initiated.

The east-facing coast of North Sound is in the process of being developed; this area received minor wave damage from water driven across the longest reach of North Sound during the peak of the storm. High Rock has a history of exposure to strong waves once winds are out of the southeast; large boulders at ~30 ft above sea level were reportedly carried there during the 1932 hurricane. In this area, houses ~25 ft above sea level received extensive wave damage. At Ocean Club/Mariner's Cove, onshore winds came around 11 am on 12 September and quickly devastated these two resorts. They had no protection from either reefs or from any significant height above sea level. Wave heights here were probably lower than at High Rock, with erosion by waves occurring up to about 15 ft above sea level. The final area of damage was on the south-facing stretch of West Bay, where onshore winds late in the storm drove waves into Dolphin Point and other resorts in this area, causing widespread damage. Estimated wave heights here were 10-15 ft.

As previously mentioned, the main stretch of developed coastline, and Grand Cayman's primary tourist attraction, is the west-facing Seven Mile Beach. The west coast of the island has no shallow reef protection, and strong onshore winds during future storms may cause much more extensive damage from wave action than resulted from storm surge flooding on this occasion.

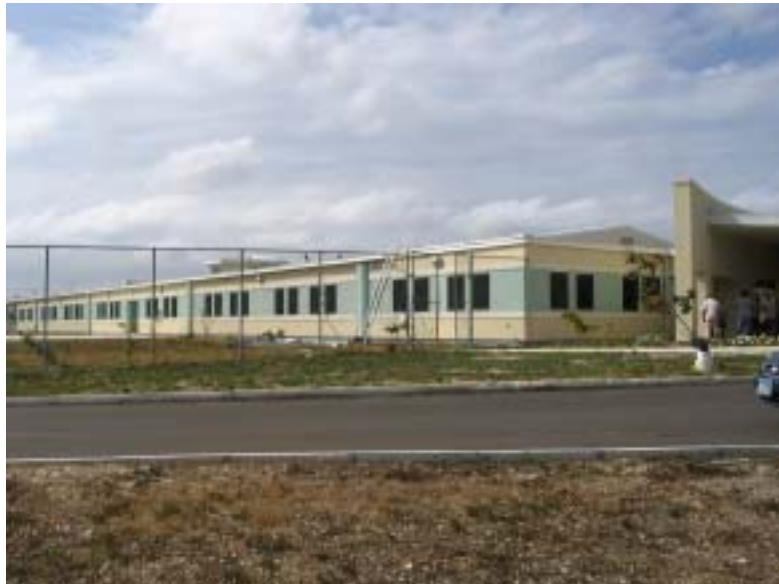
Figure 3.2 No damage was inflicted at the new Prospect Primary School, which served as a shelter for 700 people.

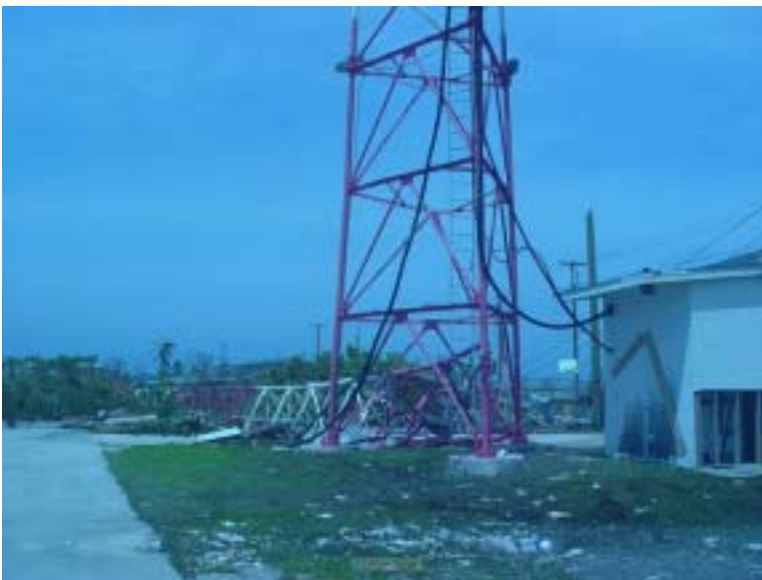
There was damage to a very few telecommunications towers (Figure 3.7). Overhead landlines are typically carried on the same poles as the electricity distribution cables. The loss of distribution poles was about 10 to 15% (see details below).

Figure 3.7 Upper segments of tall communications tower blown off by Ivan

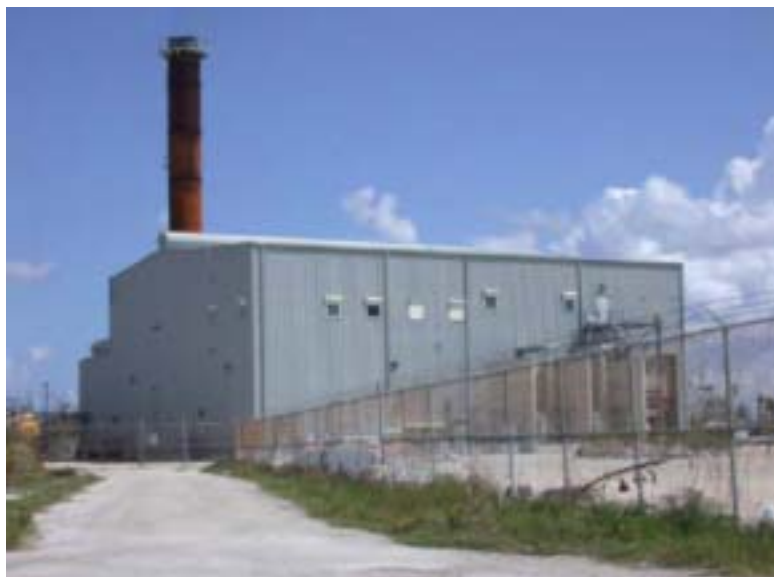
The main power generation plant was virtually undamaged by Hurricane Ivan (Figure 3.9).

Figure 3.9 Main generating plant on Grand Cayman, largely undamaged by Ivan.

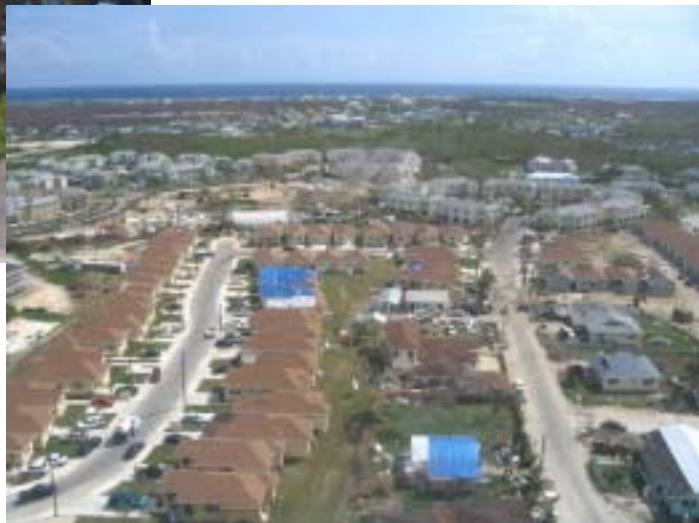
Figure 3.21 New housing in Windsor Park, George Town. Most of the asphalt shingles stayed on despite the strong winds.

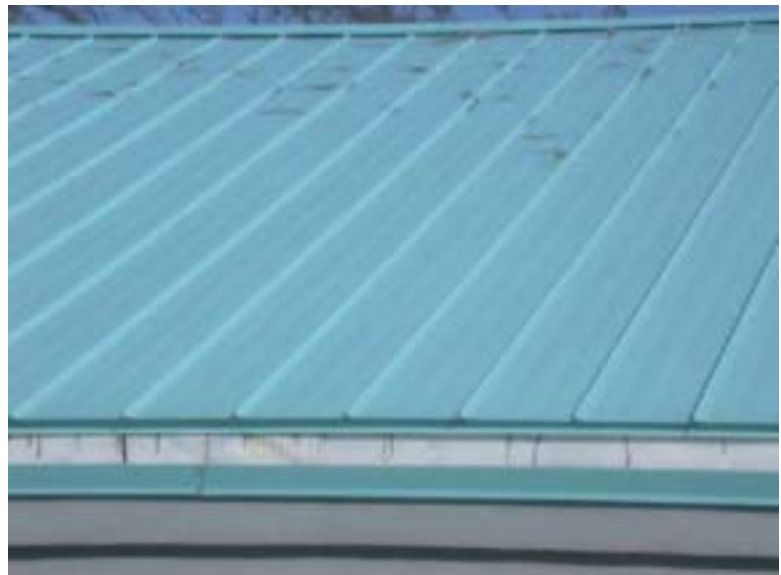
There was loss of roof coverings. The old, arc-tangent (corrugated), galvanised steel sheets did surprisingly well (Figure 3.20). This is probably due to the thicker gauge metal that was common in less competitive times. Asphalt shingles were the worst-performing covers. The manufacturers' trade association in the USA do not recommend their use in high-wind areas and most newly fitted shingles actually significantly outperformed their stated limits (Figure 3.21). Concrete and clay tiles were lost from many roofs (Figure 3.22). They are usually fixed only at the rear (upper ends) of the tiles. This method of fixing provides inadequate lever-arm resistance. In addition, the smaller the element the higher the wind pressure (force per unit area) to which the element would be subjected in a hurricane. The best-performing roof covering was standing seam metal roofing (Figure 3.23).

Figure 3.23 Standing seam roofing did very well in Ivan.

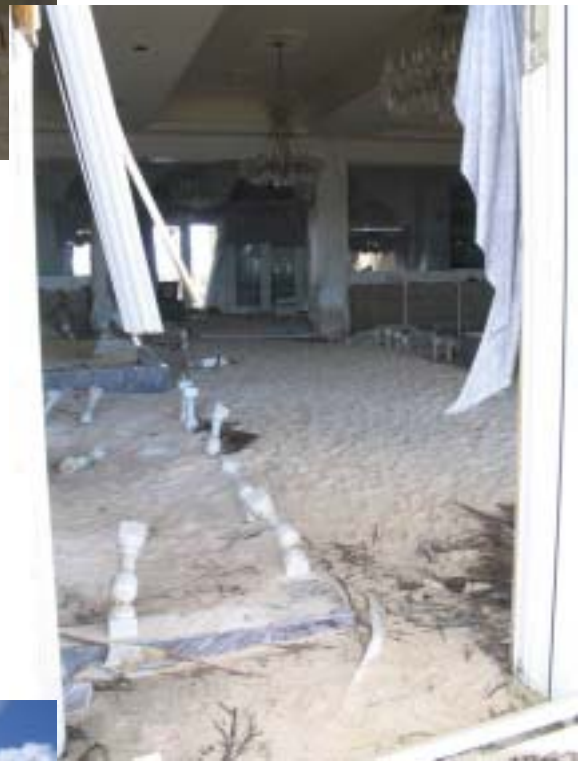
Many residential structures along the south coast suffered from removal or addition of sand and strong storm surge ingress (Figure 3.25). A few others suffered severe wave damage in the exposed High Rock area along the south coast (Figure 3.26).

Figure 3.26 Extreme wave damage at High Rock; this property is about 25 ft above sea level and several hundred feet from the shoreline.

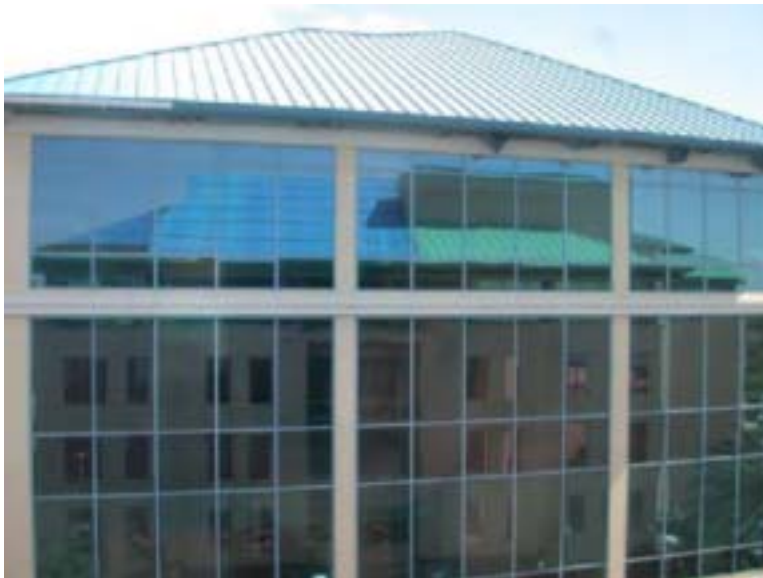
Window protection against flying debris is becoming more usual. Either shutters fixed to buildings (integrated in the original design of buildings) are used or laminated glazing is installed (Figure 3.27). These strategies worked satisfactorily.

Figure 3.27 Laminated glass performed very well in office buildings throughout Grand Cayman.

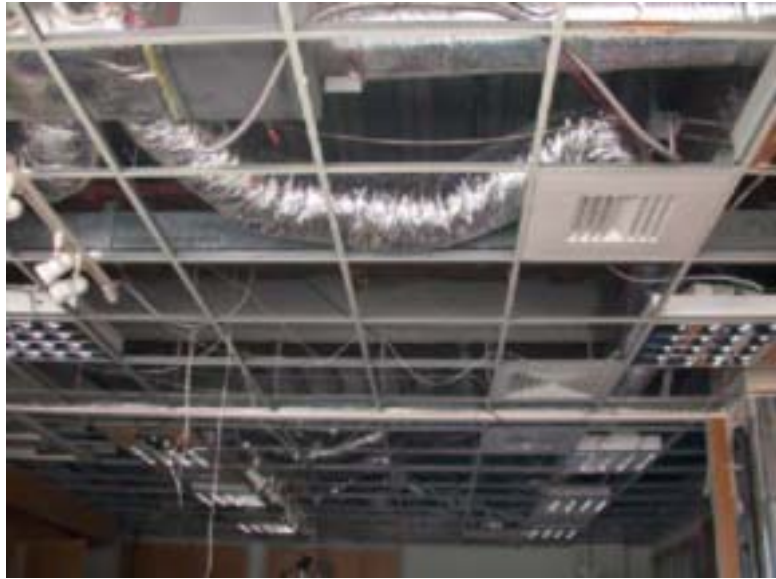
There were cases where the buildings appeared to be virtually undamaged but where the normal functioning of the offices was not possible after Ivan because of significant internal damage (Figure 3.28). The detailing of window assemblies, the detailing of the installation of window assemblies in external walls, the detailing of external doors and the fixing of waterproofing membranes on concrete roofs are all areas requiring more care in the design and construction phases of projects. It was surprising how much rain water could enter a buildings which suffered no visible external damage.

Figure 3.28 Significant internal damage was caused by rain ingress through minor breaches in the building envelope.

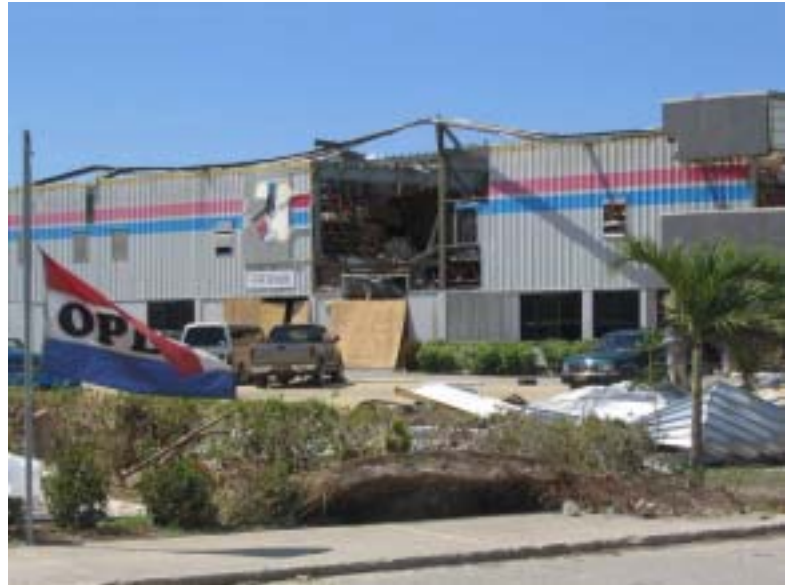
Smaller commercial and retail buildings generally did not perform well during Ivan. A number of flaws in design and/or construction were highlighted by the high winds. A number of 'strip-mall' type buildings were destroyed or severely damaged (Figure 3.29), and long-span galvanized arc-tangent sidings and roofs were ripped off (Figure 3.30) and became damaging debris (Figure 3.31).

Figure 3.30 Long-span galvanised siding blown out and subsequent loss of a large part of the building.
